MICROSCOPIC ASPECTS OF
WEAR PROCESSES IN METALS

Jan. 1, 1981 - Dec. 31, 1981
Annual Report
N00014-80-F-0032
NR 091-011

SLIDING WEAR BEHAVIOR OF ELECTRON BEAM SURFACE MELTED O-2 TOOL STEEL

OBSERVATIONS ON THE WEAR-IN PROCESS DURING THE SLIDING OF SEVERAL COPPER ALLOYS AGAINST 52100 STEEL

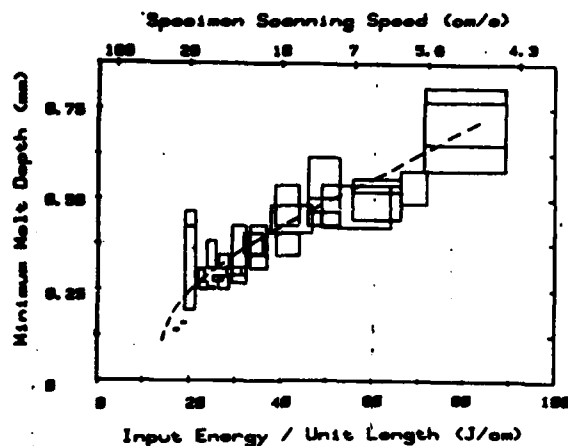
Fig. 6 Variation of minimum melt depth with specimen surface scanning speed (for 400 watt beam), and with input energy per unit length. Rectangles indicate ranges of observed values.

A number of experiments were conducted to explore the effect of different surface scanning speeds on the resulting solidified structures. Figure 6 shows the measured relationship between minimum melt depth with surface speed and energy input per unit length (for a 400 watt beam). The maximum melt depth is about twice as large and would correspond to the depth for a single pass. The range in melt depth values is shown by the height of the rectangle plotted that contains the actual measured values. This range is due to fluctuations (e.g. beam power) from pass to pass and the gradually increasing block temperature. The variation in input energy per unit length shown by the width of the rectangle plotted is due to fluctuations in the beam power and scanning speed. There is an approximately linear relation between input energy per unit length (beam power/scanning speed) and melt depth over the region of interest.

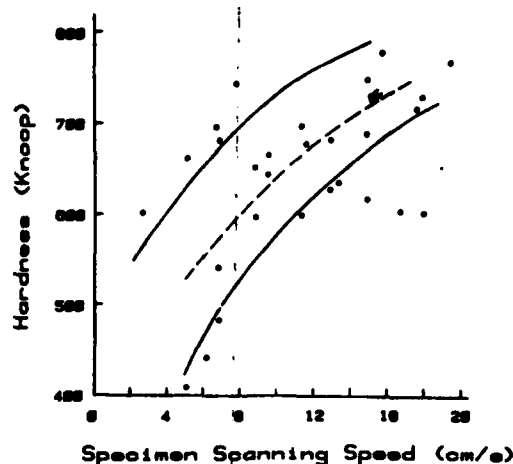
Fig. 7 Measured microhardness (Knoop) vs specimen surface scanning speed (400 w beam power). Scatter results from variation in hardness found through the melted volume.

Measurements of the microhardness of the melted regions were carried out on cross-sections of several specimens. Figure 7 shows the results of Knoop microhardness determinations plotted against surface scanning speed. For each specimen at a given scanning speed there was a range of microhardness values corresponding to different locations in the melted volume. The curve marked average indicates the observed trend of increased hardness with increased surface scanning speed for locations in the middle of the melt depth. Maximum hardness values of about 800 KHN were observed near the bottom of the melted layer; these are larger than those measured on the bulk quenched and tempered steel specimens. In

general the hardness values increased with specimen scanning speed, probably as a direct result of the faster solidification rates associated with the higher scanning speeds.

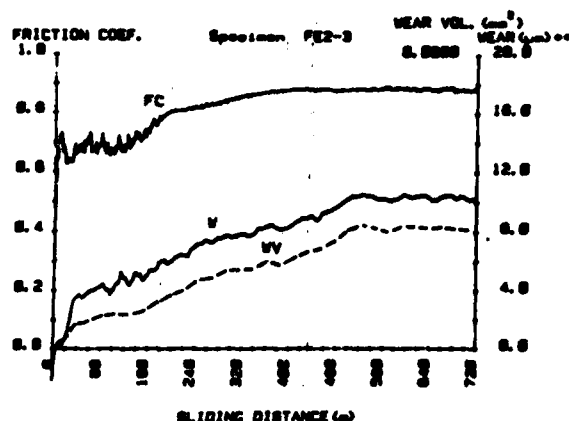
Fig.8 Friction coefficient (FC), wear (W), and wear volume (MV) curves for an electron beam melted specimen of 0-2 tool steel.

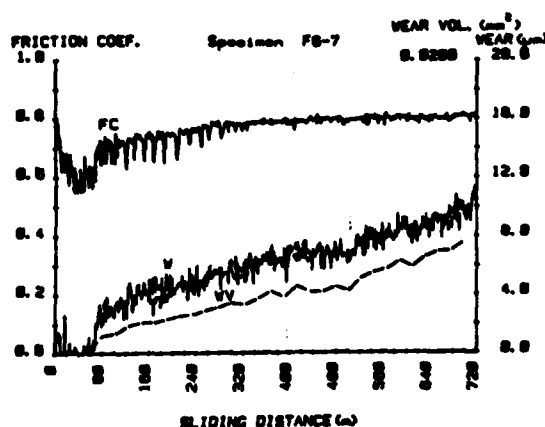
Fig.10 Friction coefficient (FC), wear (W), and wear volume (MV) curves of quench hardened and tempered 0-2 tool steel specimen.

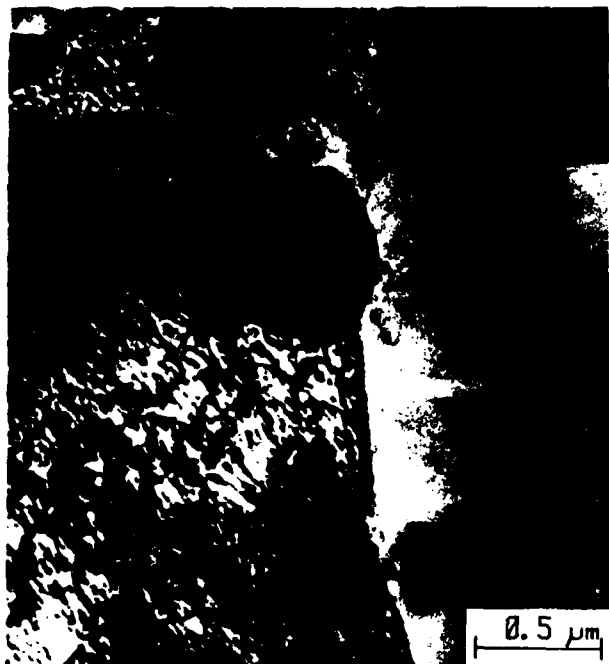
Fig.13 Transmission electron micrograph from an annealed 0-2 tool steel specimen. Large spheroidal carbides and a relatively undeformed ferrite matrix were characteristic.

Transmission electron microscopy studies were carried out on each of the three types of specimens. The annealed specimen microstructure consisted of large, spheroidal carbides of the cementite structure (according to electron diffraction data) in a ferrite matrix (Fig. 13). Some of the large carbides remained after the quench and temper treatment was applied to the second group of specimens. As seen in Fig. 14, the structure also contained tempered, twinned martensite. Tempering of the martensite was evidenced

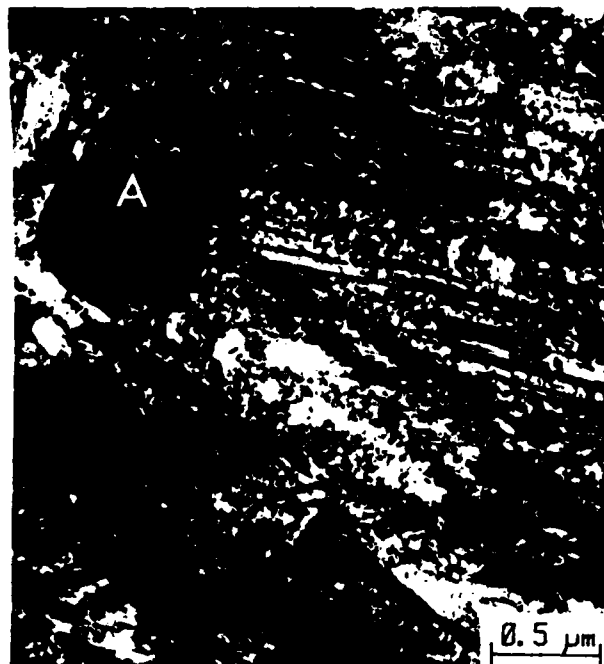
Fig.14 Transmission electron micrograph from a quenched and tempered 0-2 tool steel specimen. Some large carbides (A) remained but the characteristic structure was a tempered, twinned martensite.

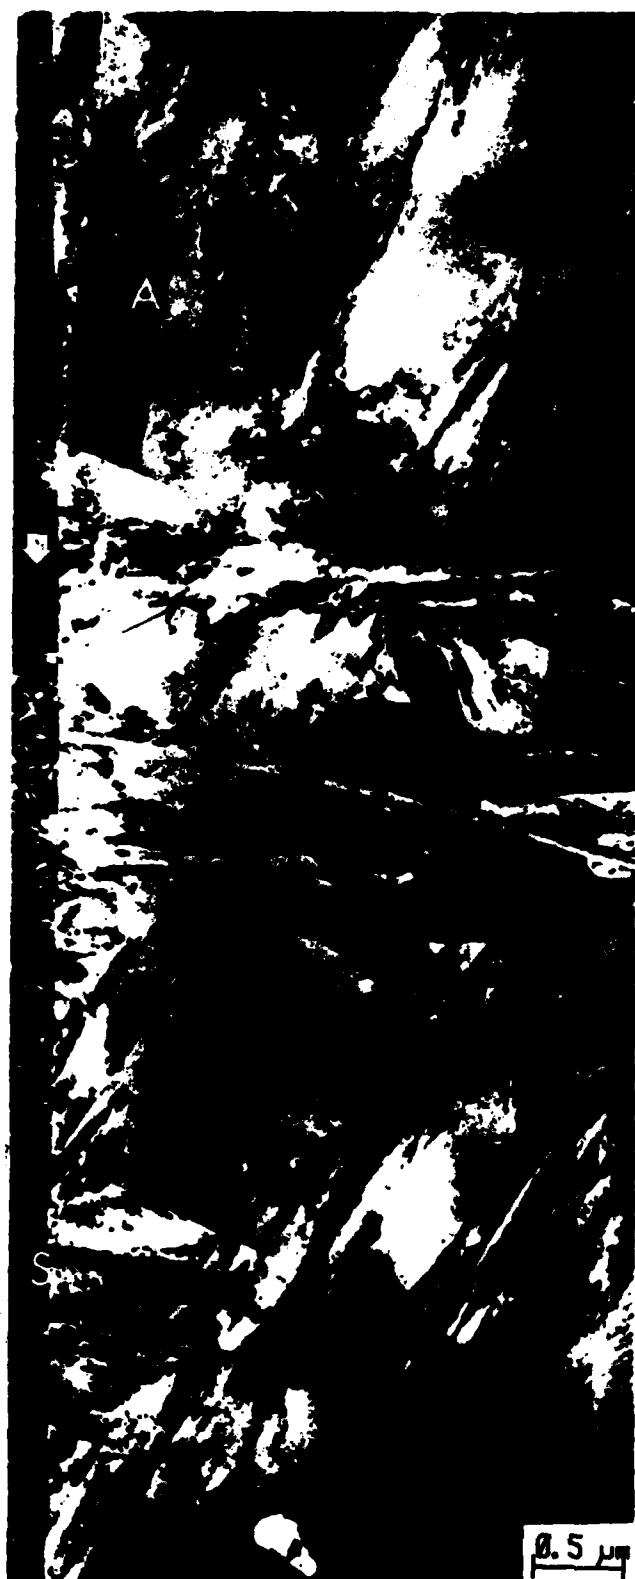
Fig.15 Transmission electron micrograph showing a cross-section through a wear track in the electron beam surface melted O-2 tool steel.

A cross-section through a wear track in the electron beam surface melted material is shown in Fig. 15. The sliding direction is indicated by the arrow. The material to the left of the line(s) representing the wear surface trace in these electron micrographs is electrodeposited nickel that was used to protect the surface during preparation of the thin

foil section. This set of micrographs indicates the type of structure that was typical of all thin sections studied from four different wear tracks on these specimens. To the right of the wear surface trace one sees the microstructure typical of the electron beam melted material. It consisted of tempered, twinned martensite. None of the original large carbides were found. The region below each wear track was carefully examined to identify the damage zone and any features resulting from wear. As shown in Fig. 15 the worn surface appeared very smooth in all the sections studied at these relatively high magnifications. Optical and SEM results from the worn surfaces also indicated some regions appearing relatively smooth and polished. Other regions (see Fig. 12) within the wear scar showed a roughened surface, however. There were some indications in the TEM results of damage located very close below the wear surface. Some twinned regions in the martensite such as at A in Fig. 15 appeared bent in the sliding direction. However, the evidence found indicates the deformation damage extended no further than about 50 nm deep from the surface. This finding is consistent with the relatively hard (Knoop hardness 800 or greater), fine structured alloy that resulted from electron beam surface melting and rapid solidification. It is possible that the specimen preparation methods used here might have removed some material unintentionally from the wear surface; further experiments are planned to explore this possibility. Examination of the wear debris produced showed the presence of both metal and oxide particles. The particles were relatively small, less than 0.5 μm, and the larger ones may have been formed by combination of smaller particles. The water vapor content of the argon atmosphere used probably contributed to the oxidation process during wear.

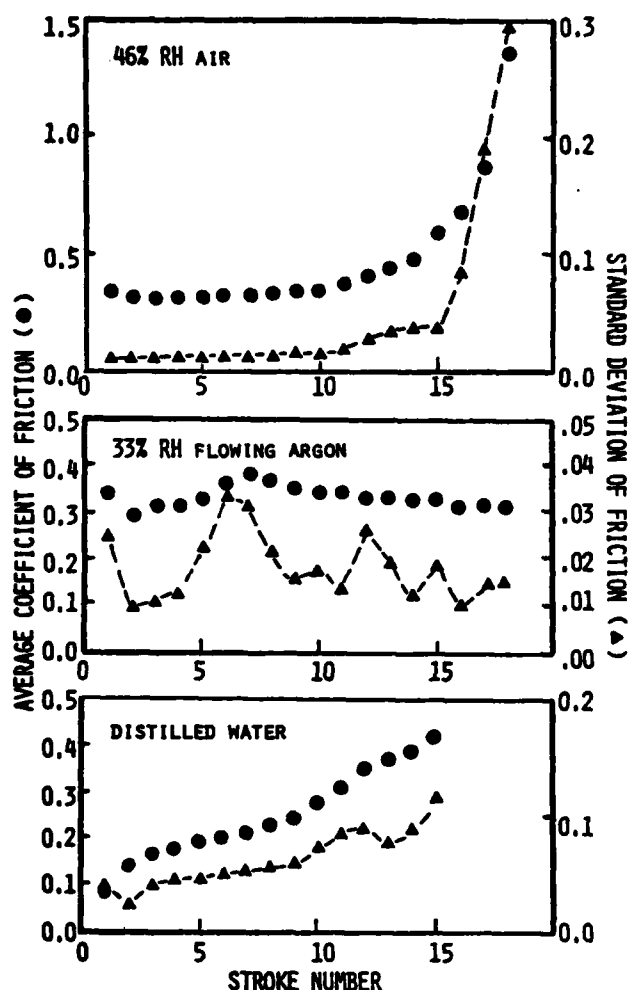
Fig. 3. Variations in the stroke by stroke frictional behavior of Cu in three sliding environments.

Figure 3 demonstrates the manner in which the averages and standard deviations of the kinetic friction coefficients changed from stroke to stroke in three sliding tests for Cu. Each plotted point represents a sampling of 81 values measured at 0.25 mm intervals along the 2.0 cm long sliding track. The three runs exemplify environmental effects on frictional break-in's. For the run in air, there was a rapid increase in both average friction and standard deviation of friction over a period of only about four strokes once severe wear-in began; whereas, for the lower humidity run, average friction changed little while the standard deviation varied erratically from stroke to stroke. When rider and flat were tested in distilled water, both the average friction and standard deviation gradually increased. Interpretation of these results and others like them must address many possible environmental interactions, including for example:

While data such as that in Fig. 3 can provide useful information about general trends in friction and wear mode transitions in given sliding systems, to identify the fundamental mechanisms, more detailed knowledge about the evolution of surface damage is needed. To this end, the appropriate computer software was written to plot kinetic friction versus location on the wear track for each subsequent pass of the slider.

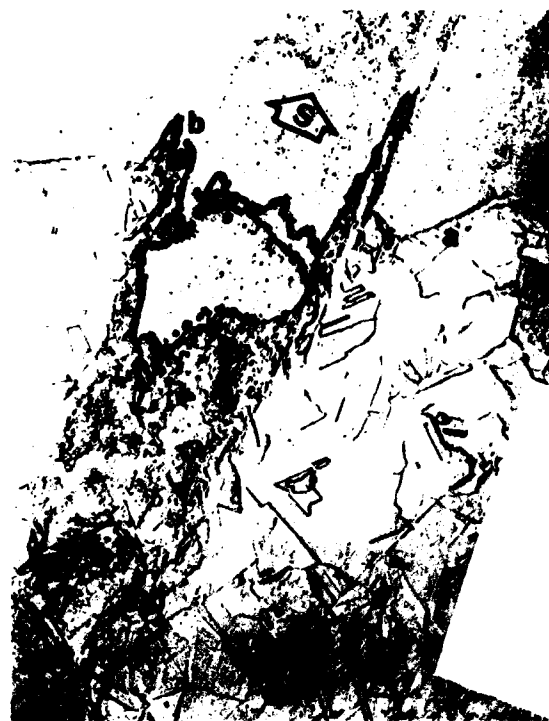
Fig. 5. Polished cross-section of the track in Fig. 4. Inclining the plane of polish produced enhanced magnification of surface features and subsurface deformation. Areas of mild scoring (a) and a raised lip (b) correspond to Fig. 4 features.

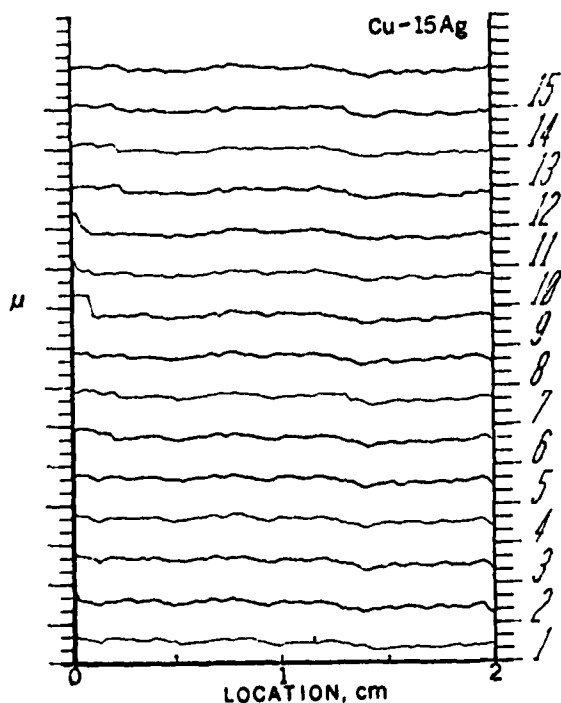
Fig. 6. Wear history of a Cu-15%Ag (in air) specimen showing little variation in friction and similar behavior from one stroke to the next.

Figures 6, 7 and 8 represent the frictional "histories" for Cu-15wt%Ag, Cu-7wt%Al and OFHC Cu flats all tested in air with similar loads (4.9 N) and sliding velocities (0.5 cm/s). Each vertical scale unit is 0.1 of friction coefficient (μ) and the zero-friction base-lines for each successive stroke are indicated at the right side of the figures. By scanning the plots from bottom to top, one can observe the changes (or lack thereof) in friction at any point along the wear track. For example, the stroke by stroke change in

In contrast to Cu-15wt%Ag (Fig. 6) the Cu-7.0wt%Al alloy (Fig. 7) did not show the reproducibility of features or subsequent friction traces. This could indicate that substantially different wear surface features were produced at a given location during each stroke. Such observations can help to identify the extent to which the characteristics of prior wear surface influences longer term deterioration.

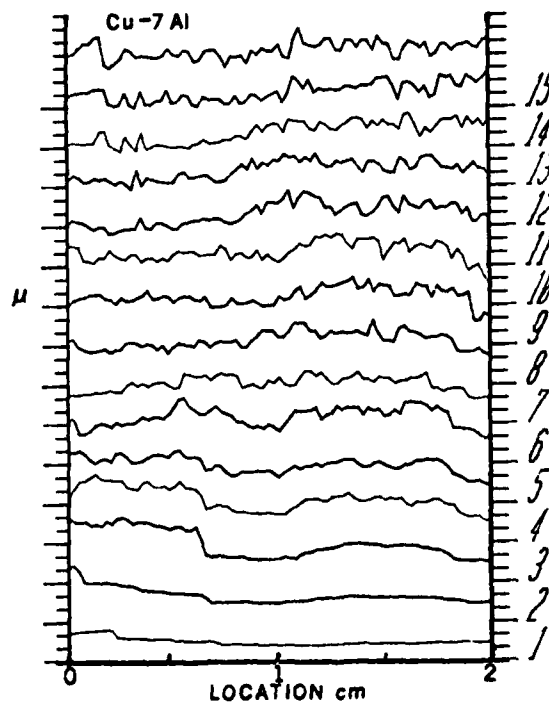
Fig. 7. Rapid, early transition from low steady friction to higher, more erratic friction in a Cu-7%Al alloy (in air).

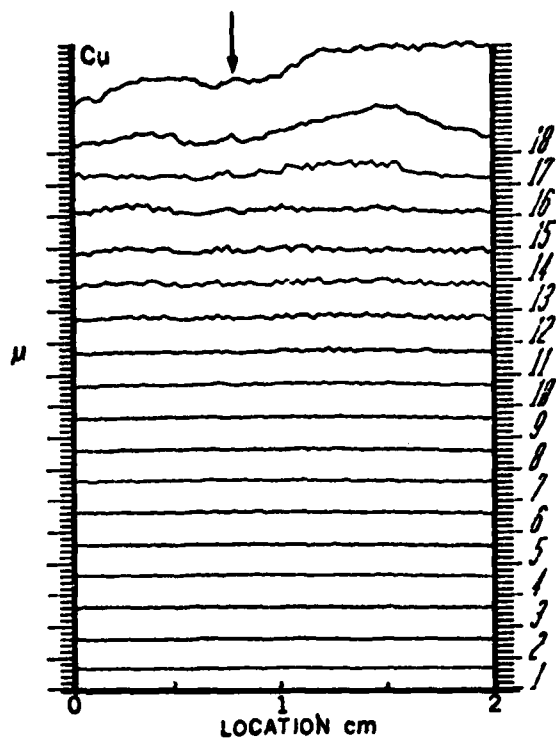
Fig. 8. Small localized frictional variations precede a large transition in friction in a test of Cu in air. Higher friction at the right end of the track may result from metal transfer to the slider after about the first cm of travel.

One notes in such representations as Fig's. 6 through 8 that once certain features develop from stroke to stroke on a track, their influence may often aid in the further deterioration of the track. In Figure 8, for example, one might suggest that the plateau-shaped, high friction region developed on the last stroke may have arisen from material transfer to the rider ball surface at the "upstream" location indicated by the arrow. If a built up transfer film was formed so as to promote Cu-on-Cu sliding, one might expect to see higher friction, more effective load transfer to the flat, and therefore a greater potential for track deterioration. Sasada, et al [15] addressed this issue in a previous paper. Some of the plowed-up debris may have lead to adhesive removal of the transferred material at the end of the track so that the transfer process would need to be reinitiated on each subsequent stroke.

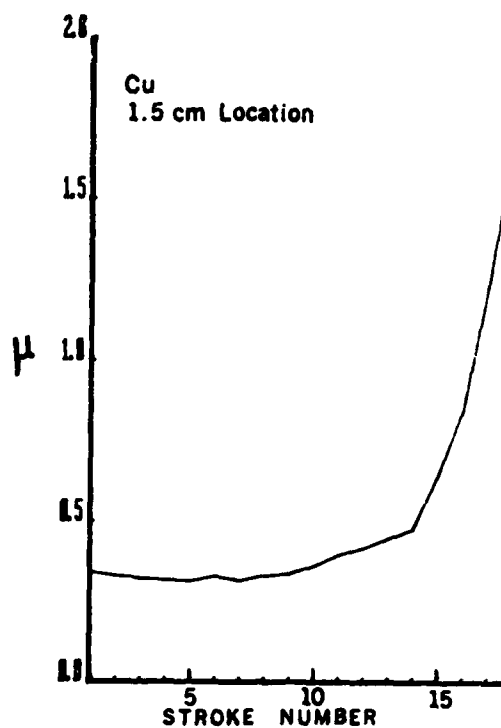
Fig. 9. Change in friction from stroke to stroke for a point 1.5 cm down the wear test track, Fig. 8. Most rapid changes occurred during strokes 14 to 18.

friction for a point 1.5 cm along the track of Fig. 8 has been plotted in Fig. 9. The usefulness of such formats lies in the study of microstructural contributions to wear and friction break-in behavior, since it is possible to examine structural features produced at locations with documented frictional histories.

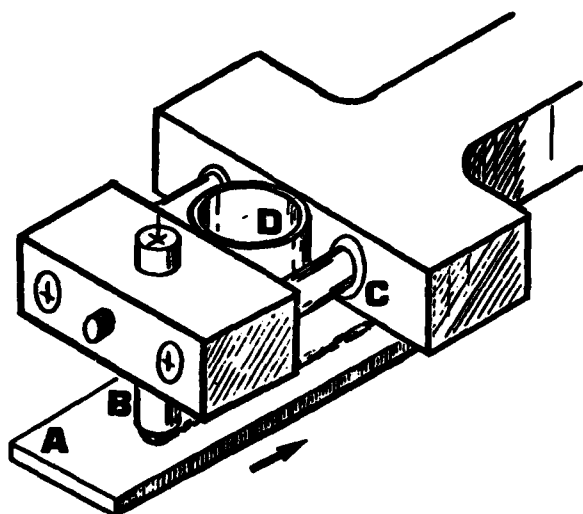
Fig. 2. Schematic of the linear tribometer head: (A) specimen, (B) ball rider on a brass stub, (C) precision linear ball bushing, (D) strain ring with gauges.

The tribometer used for the current studies was computer controlled and operated in a linear, stroke-by-stroke fashion [12]. Figure 2 represents the basic test geometry. Friction forces were measured using a strain ring which was calibrated before each test and monitored for signal stability and drift between each stroke during the test. The current series of tests were all conducted using a fixed 52100 steel ball bearing rider (0.635 cm in diameter) with a load of

500 g (4.9 N) and a sliding speed of 0.5 cm/s. Stroke length was 2.0 cm and 81 values of frictional force were recorded for each stroke. In this way, friction was recorded as a function of rider position at 0.25 mm intervals along the wear track.
